# Manhole Inspection Summary

Manhole # **S43G\_\_005MH**

Insp Date: **6/2/08 10:25 AM**

**Location** Address: **1400 s caroline st** Cross Street: **unknown street**

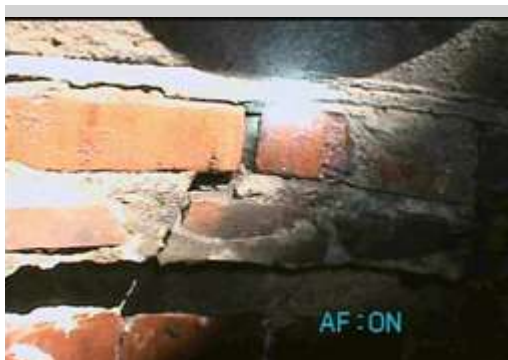
Defect 1

Condition: ☐ Sound ☒ **Cracked** ☐ Root Intrusion ☐ Loose Brick ☐ Deteriorated

chimney cond cracked

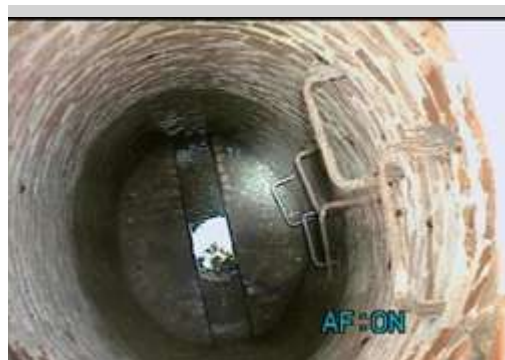
Defect 2

**Steps** Count: **6** Missing: **0** ☒ **Corroded**

**Surcharge** ☒ **Evidence Of Surcharge** Depth: **3** (ft.) ☐ Active Surcharge Present

steps & surcharge evidence

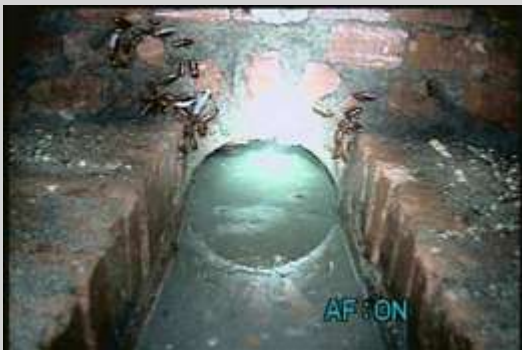
12 O'Clock Outflow

8 in. Circular Gravity Sewer  
Pipe Out @ 12 O'Clock

Invert Depth: **10.20** (ft.) Flow Characteristics: **Fast**

Deposits: ☒ None ☐ Mud ☐ Sludge ☐ Debris ☐ Grease

Infiltration: **None** Pipe Seal Cond: **Unknown**

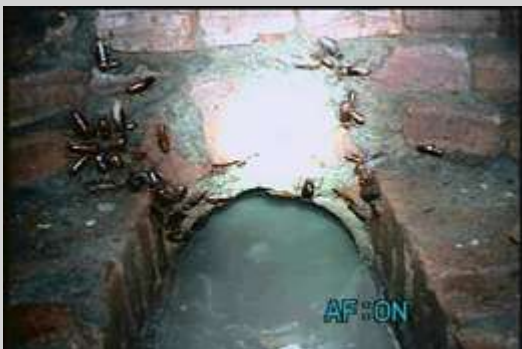
6 O'Clock Inflow

8 in. Circular Gravity Sewer  
Pipe In @ 6 O'Clock

Invert Depth: **10.12** (ft.) Flow Characteristics: **Fast**

Deposits: ☒ None ☐ Mud ☐ Sludge ☐ Debris ☐ Grease

Infiltration: **None** Pipe Seal Cond: **Unknown**
